Facility Name: <u>Quintec, Inc.</u>			
Facility Identification Number: <u>IND 000 199 653</u>			
A.1 General Correspondence <u>A.1.1-A.1.7</u>	1	B.2 Permit Docket (B.1.2)	
A.2 Part A / Interim Status <u>A.2</u>	1	.1 Correspondence <u>B.1.1</u>	1
.1 Correspondence	Y	.2 All Other Permitting Documents (Not Part of the ARA) <u>A.1.2(3), B.1.3, B.1.4, B.1.8</u>	5
.2 Notification and Acknowledgment	Y	C.1 Compliance - (Inspection Reports) <u>C.1.1</u>	1
.3 Part A Application and Amendments	Y	C.2 Compliance/Enforcement <u>C.2.2(2)</u>	2
.4 Financial Insurance (Sudden, Non Sudden)		.1 Land Disposal Restriction Notifications	
.5 Change Under Interim Status Requests		.2 Import/Export Notifications <u>C.2.2</u>	1
.6 Annual and Biennial Reports		C.3 FOIA Exemptions - Non-Releasable Documents <u>C.3.2(2)</u>	2
A.3 Groundwater Monitoring		D.1 Corrective Action/Facility Assessment	
.1 Correspondence		.1 RFA Correspondence

**RE: EPA 2009 Multi-media RCRA Inspection Report
Notice of Violation
Quemetco, Inc., Indianapolis, IND 000 199 653**

Attachment A
Inspection Photographs
Quemetco, Inc. (EPA ID No.: IND000199653)
Indianapolis, Indiana
May 18 – 20, 2009

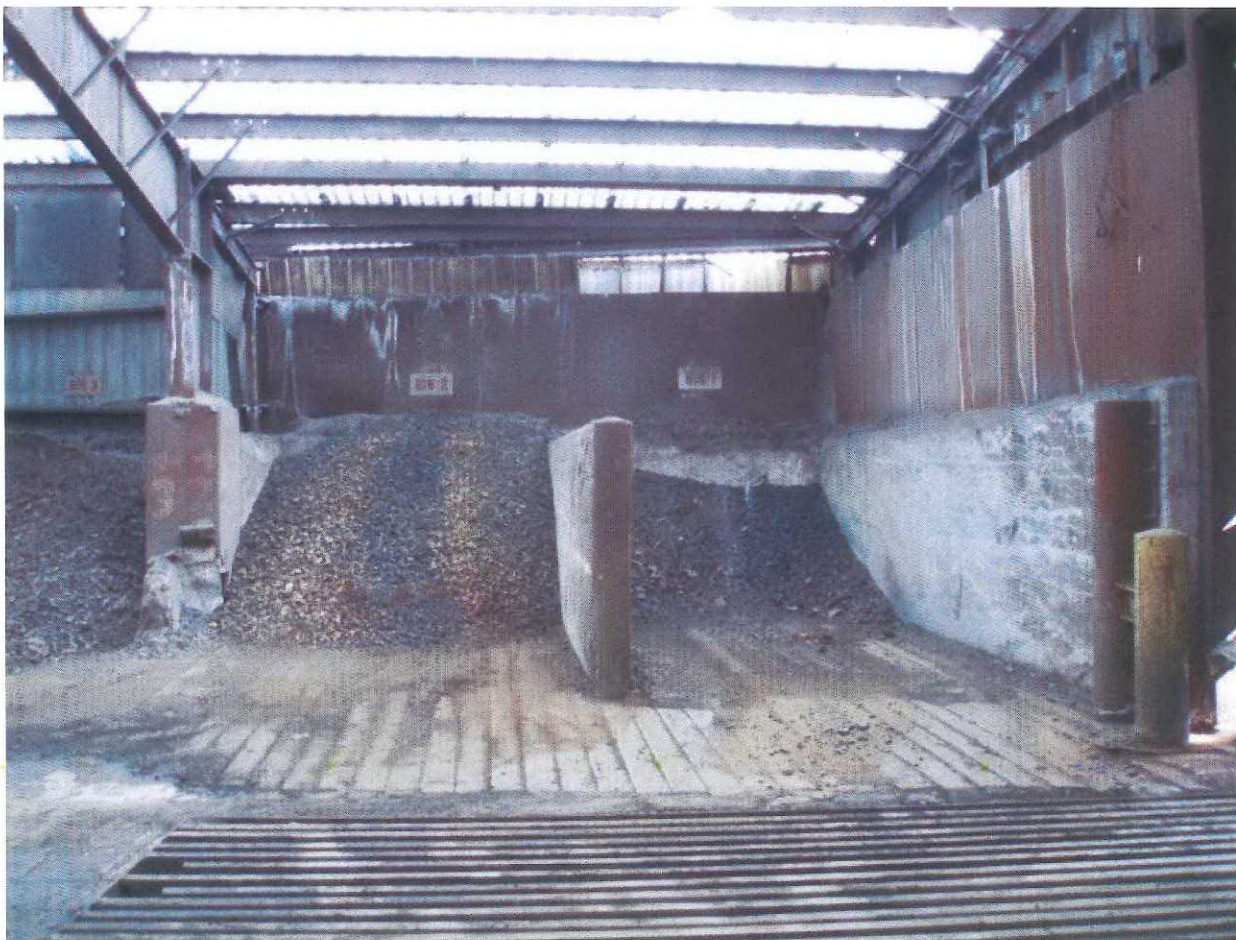
Photograph 38: Piles of slag in Bins 1 through 3 at the Slag Warehouse at Quemetco, Inc., Indianapolis, Indiana. According to Quemetco, this is slag generated from its SRF and destined for off-site disposal. The digital photograph was collected on May 19, 2009, at approximately 9:11 A.M. (CST). The photographer was Todd Brown, U.S. EPA. The filename is P5190038.

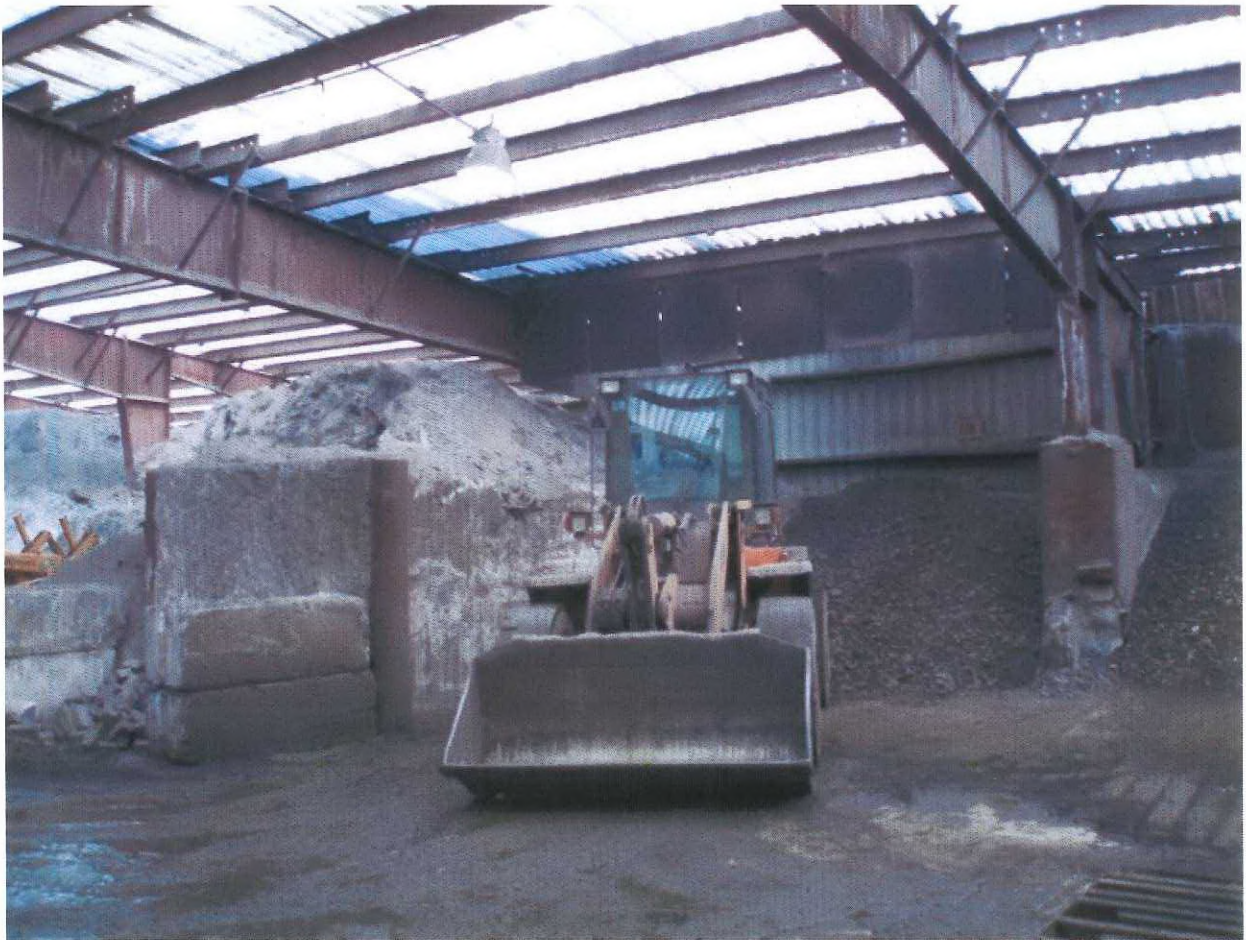
Photograph 39: Piles of slag in the Slag Warehouse at Quemetco, Inc., Indianapolis, Indiana. The digital photograph was collected on May 19, 2009, at approximately 9:12 A.M. (CST). The photographer was Todd Brown, U.S. EPA. The filename is P5190039.

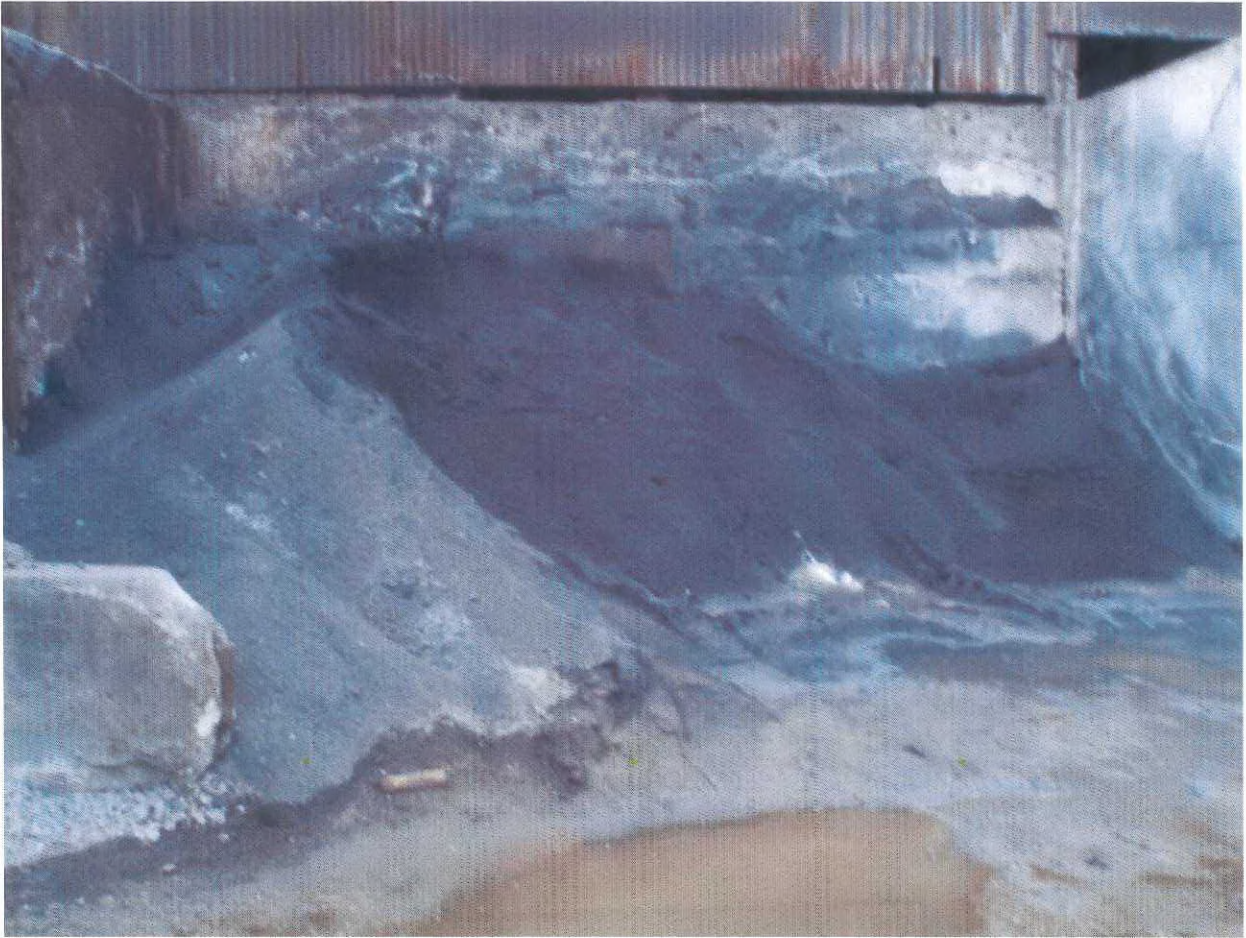
Photograph 40: Coke pile in the Slag Warehouse at Quemetco, Inc., Indianapolis, Indiana. The digital photograph was collected on May 19, 2009, at approximately 9:12 A.M. (CST). The photographer was Todd Brown, U.S. EPA. The filename is P5190040.

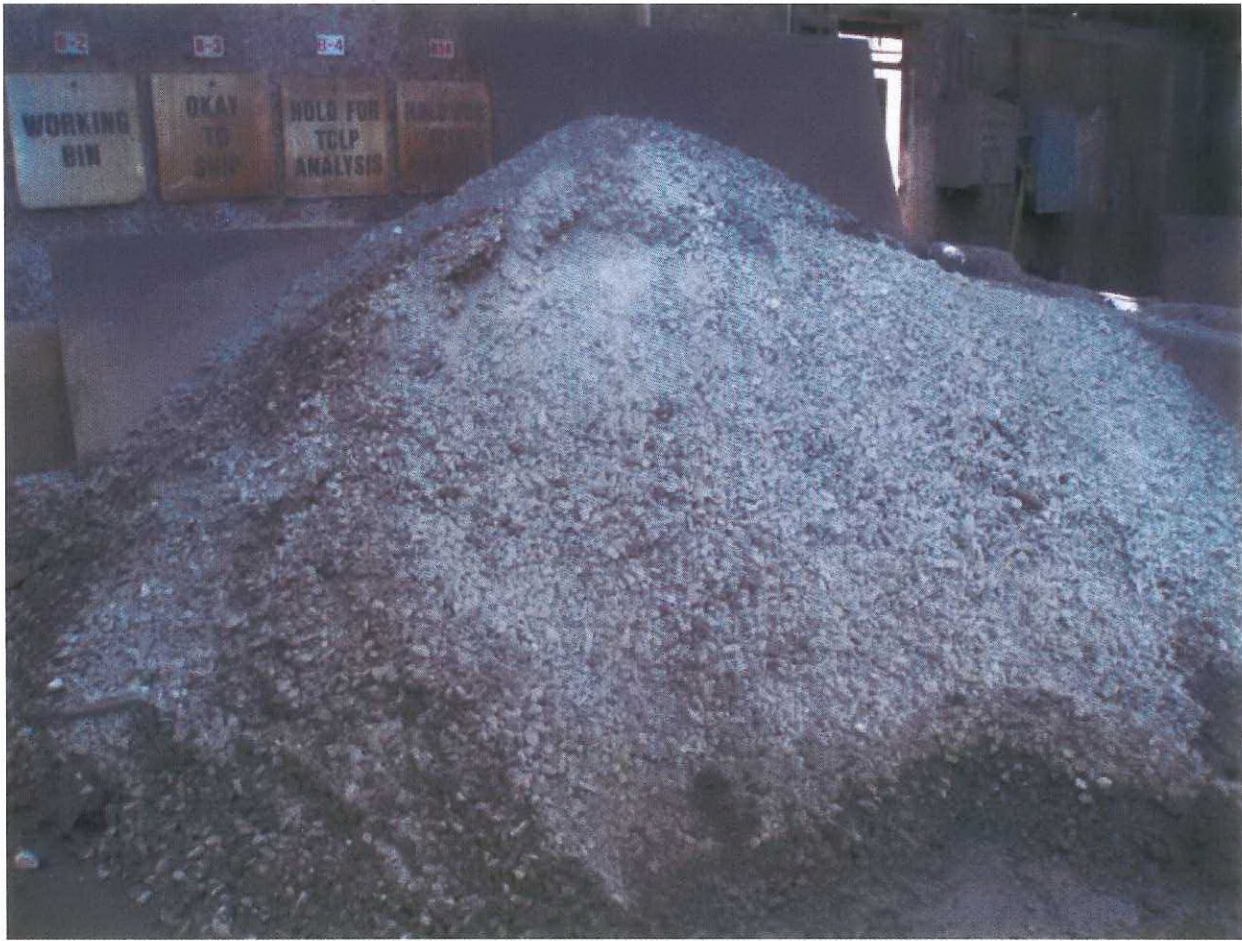
Photograph 41: Slag pile in the Slag Warehouse at Quemetco, Inc., Indianapolis, Indiana. The digital photograph was collected on May 19, 2009, at approximately 9:12 A.M. (CST). The photographer was Todd Brown, U.S. EPA. The filename is P5190041.

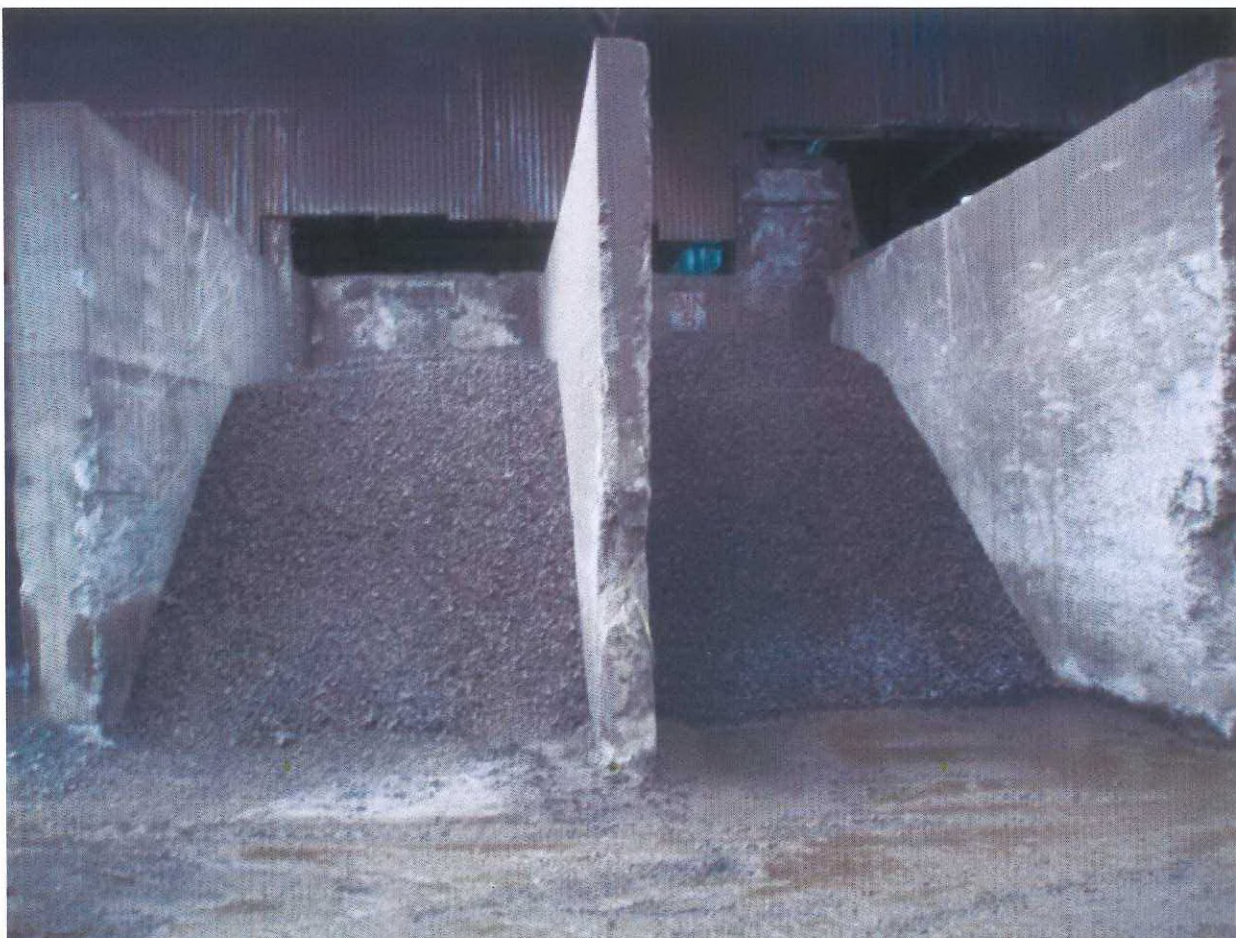
Photograph 42: Piles of slag in the Slag Warehouse at Quemetco, Inc., Indianapolis, Indiana. The digital photograph was collected on May 19, 2009, at approximately 9:13 A.M. (CST). The photographer was Todd Brown, U.S. EPA. The filename is P5190042.

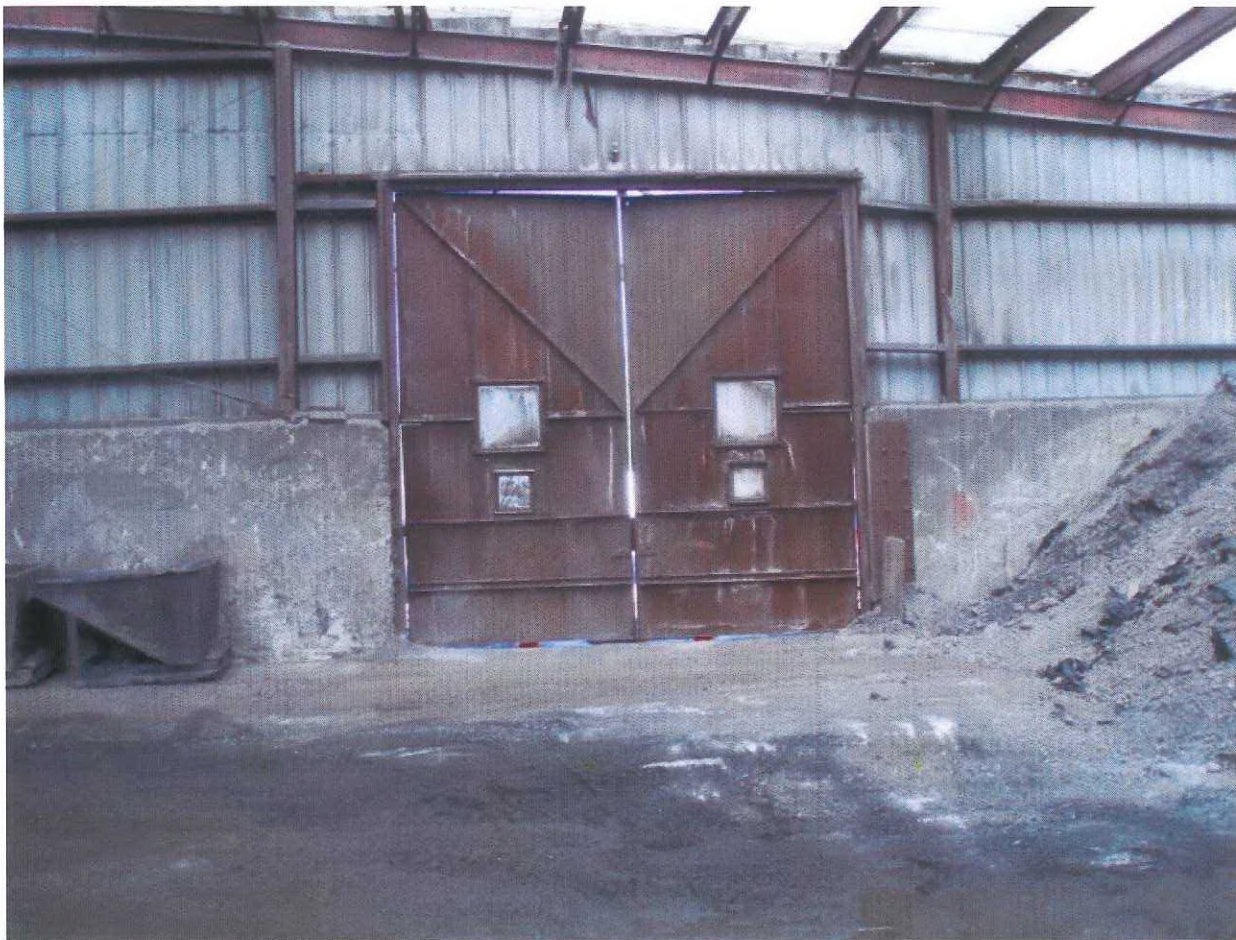
Photograph 44: Wall and door in the Slag Warehouse at Quemetco, Inc., Indianapolis, Indiana. The digital photograph was collected on May 19, 2009, at approximately 9:14 A.M. (CST). The photographer was Todd Brown, U.S. EPA. The filename is P5190044.

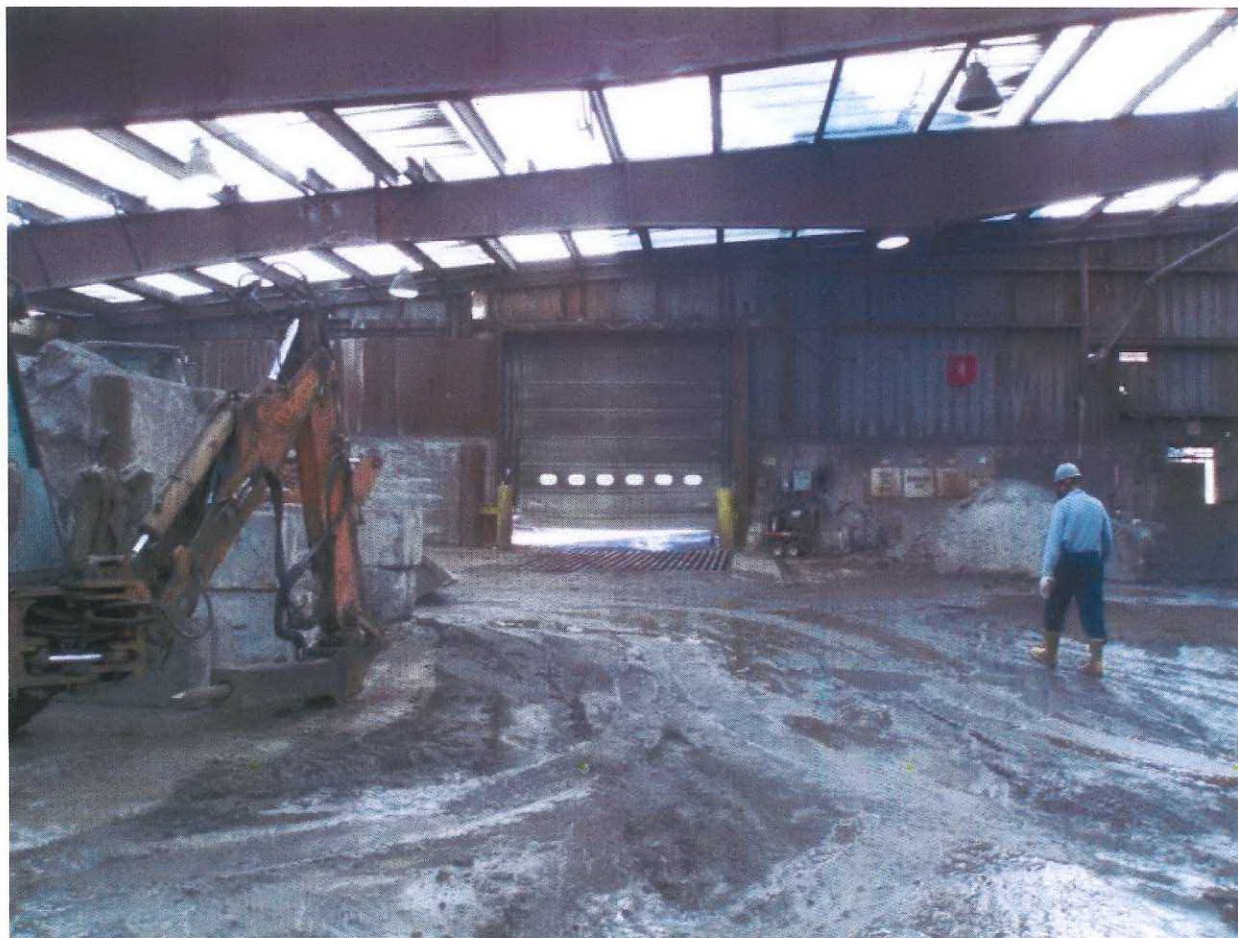
Photograph 45: Wall and door in the Slag Warehouse at Quemetco, Inc., Indianapolis, Indiana. The digital photograph was collected on May 19, 2009, at approximately 9:14 A.M. (CST). The photographer was Todd Brown, U.S. EPA. The filename is P5190045.

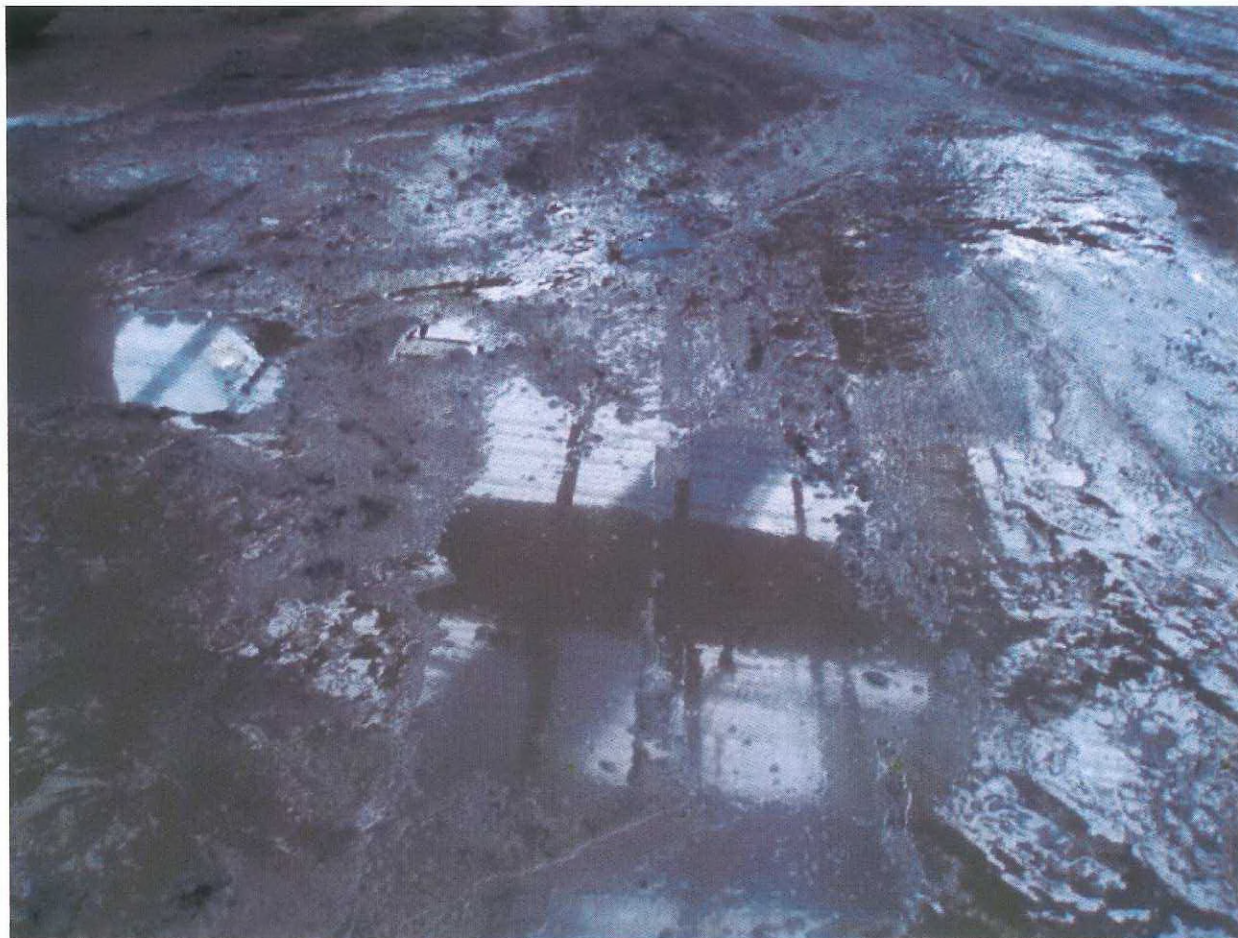
Photograph 46: Floor of the Slag Warehouse at Quemetco, Inc., Indianapolis, Indiana. The digital photograph was collected on May 19, 2009, at approximately 9:14 A.M. (CST). The photographer was Todd Brown, U.S. EPA. The filename is P5190046.

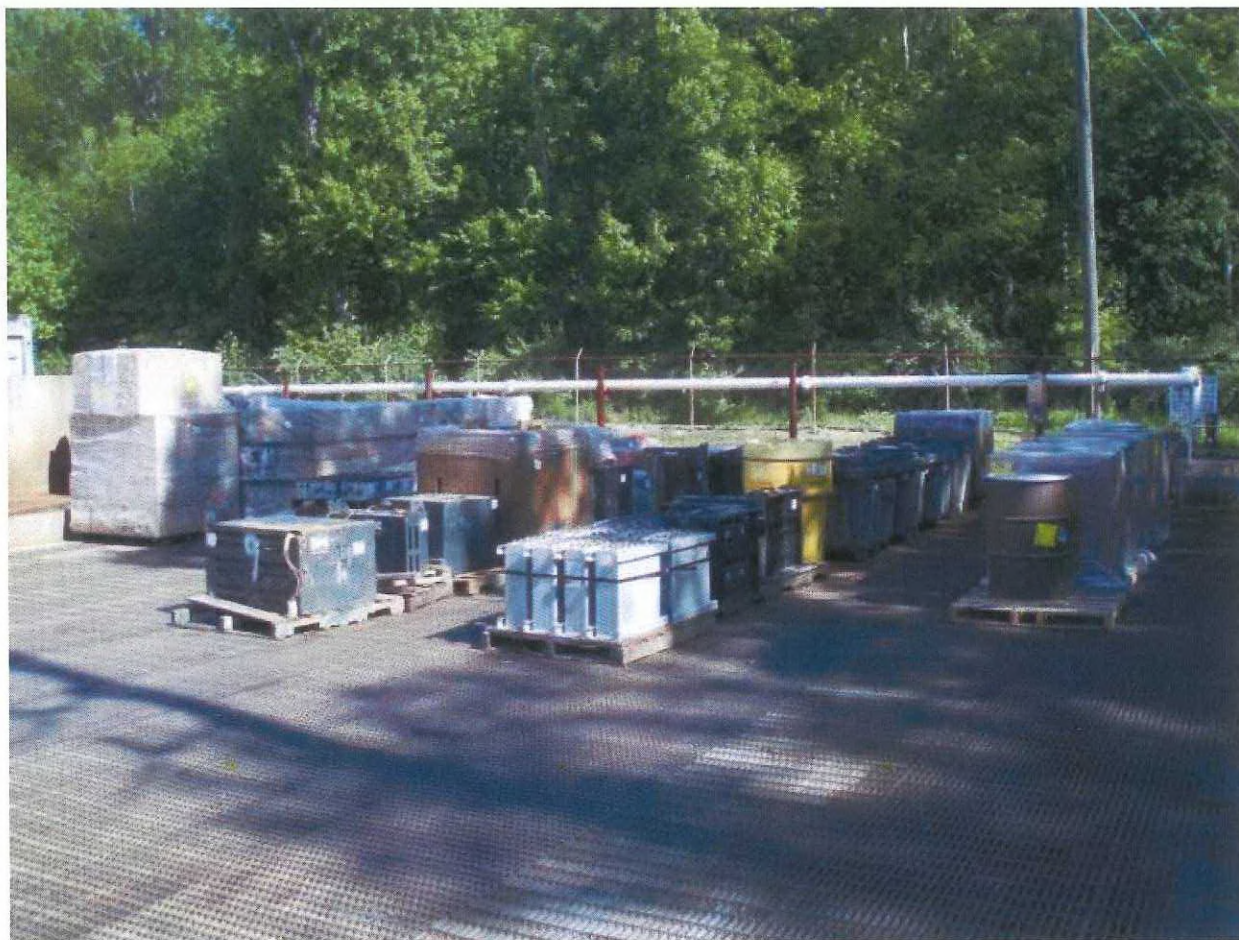
Photograph 47: Permitted Hazardous Waste Storage Area at Quemetco, Inc., Indianapolis, Indiana. The digital photograph was collected on May 19, 2009, at approximately 9:23 A.M. (CST). The photographer was Todd Brown, U.S. EPA. The filename is P5190047.

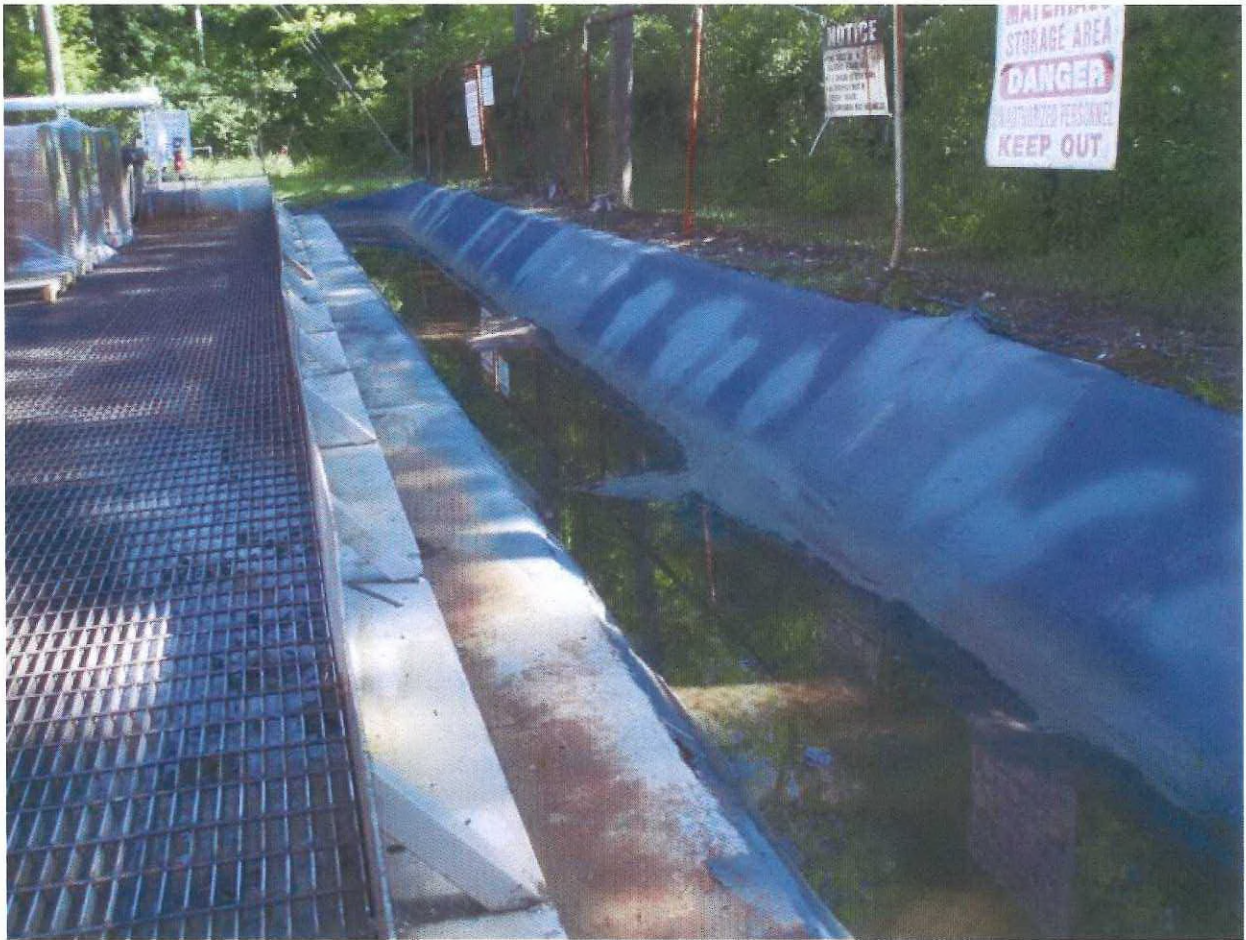
Photograph 48: Liquid collection trench at the Hazardous Waste Storage Area at Quemetco, Inc., Indianapolis, Indiana. The digital photograph was collected on May 19, 2009, at approximately 9:27 A.M (CST). The photographer was Todd Brown, U.S. EPA. The filename is P5190048.

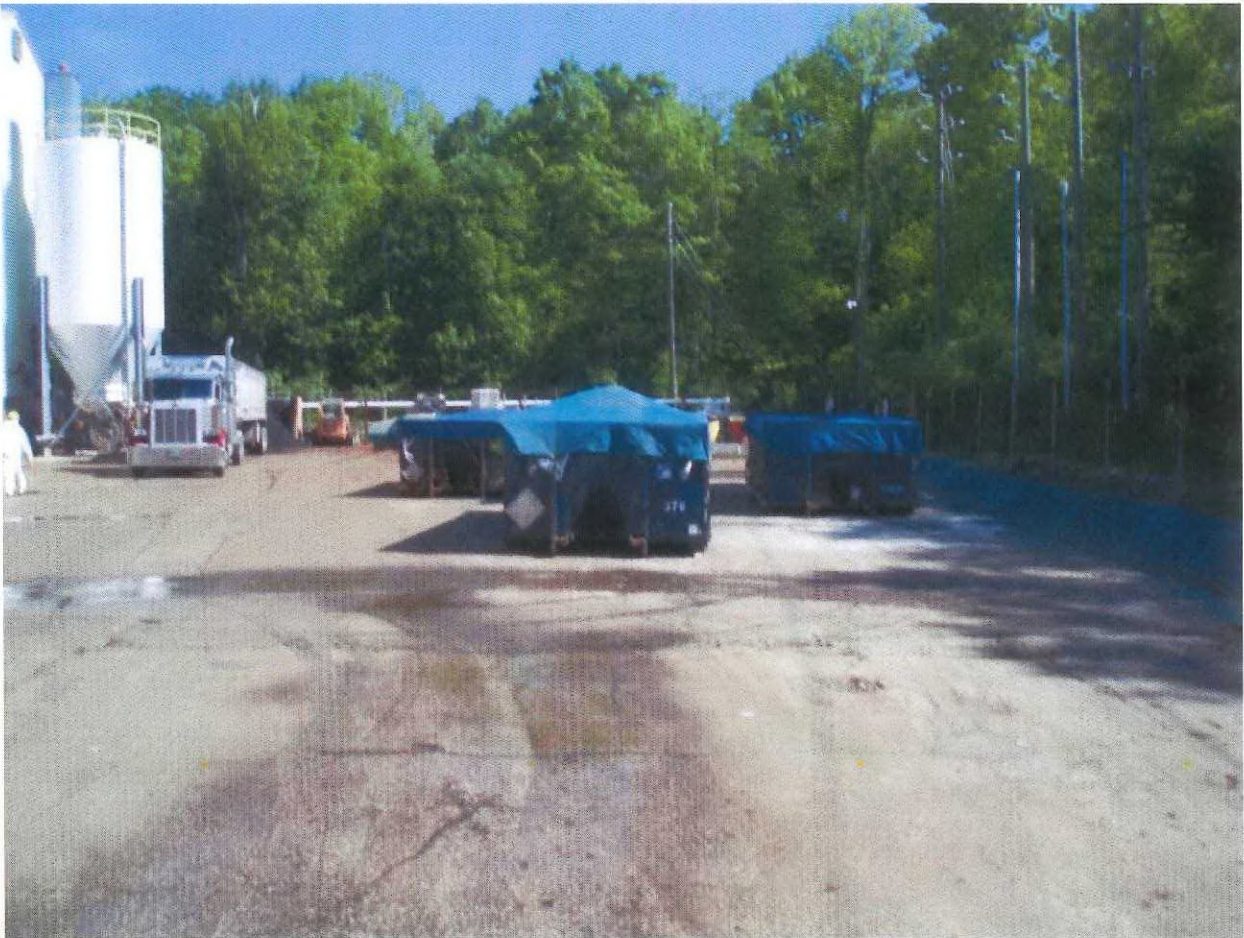
Photograph 49: Roll-off containers of gravel and concrete waste located to the immediate south of the Hazardous Waste Storage Area at Quemetco, Inc., Indianapolis, Indiana. Two were labeled as hazardous waste and two as non-hazardous waste (note: one of the roll-off containers is obscured from view in the photograph by another roll-off container). The digital photograph was collected on May 19, 2009, at approximately 9:33 A.M (CST). The photographer was Todd Brown, U.S. EPA. The filename is P5190049.

I observed four roll-off containers in an out-door area directly to the south of the Hazardous Waste Storage Area (photograph 49). Two were labeled as hazardous waste, and the two as non-hazardous waste. According to Quemetco, all four contained gravel and concrete.

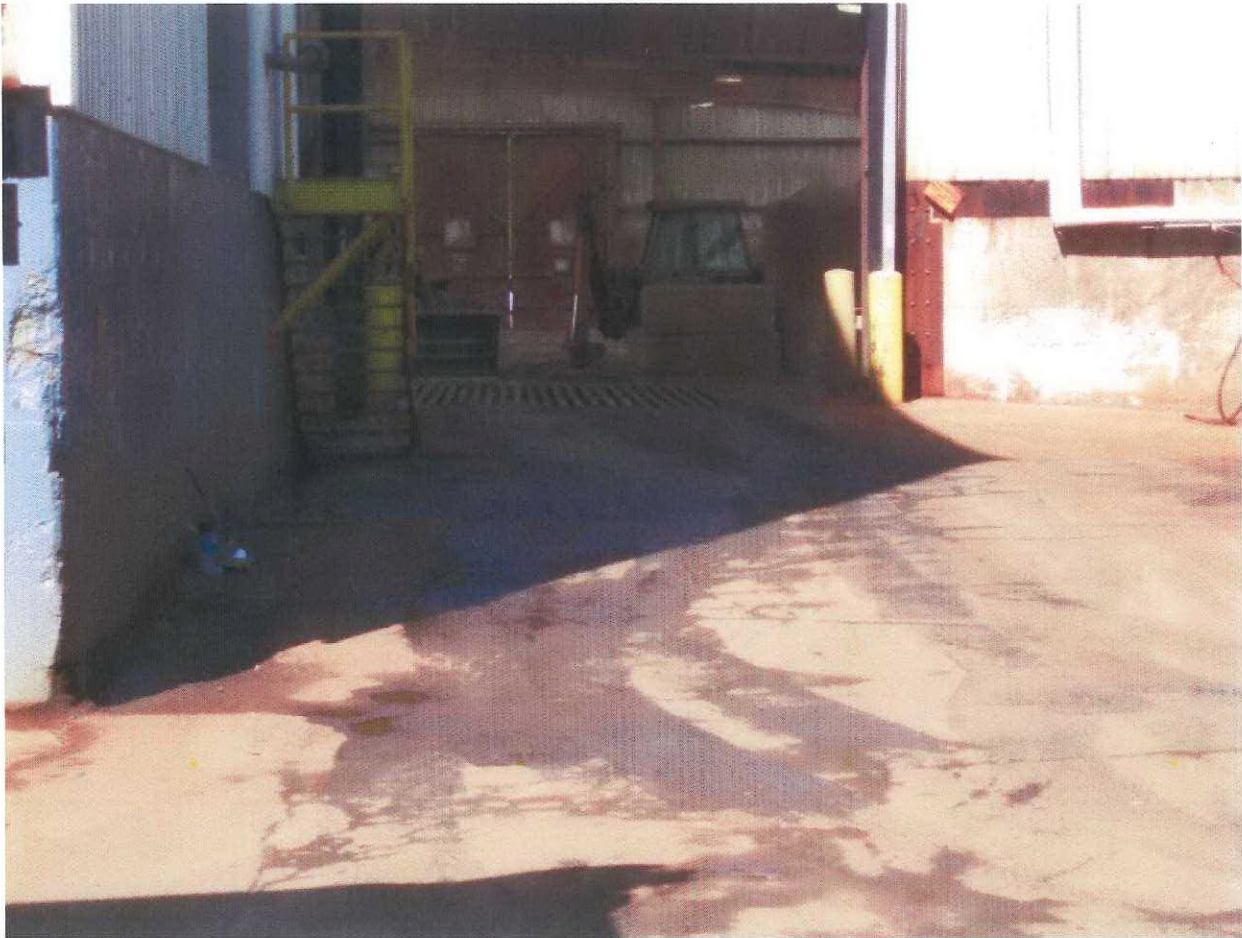
Photograph 50: East entryway to the Slag Warehouse, at Quemetco, Inc., Indianapolis, Indiana. The digital photograph was collected on May 19, 2009, at approximately 9:34 A.M (CST). The photographer was Todd Brown, U.S. EPA. The filename is P5190050.

At the conclusion of my inspection of this area, I photographed the east doorway to the Slag Warehouse (photograph 50).

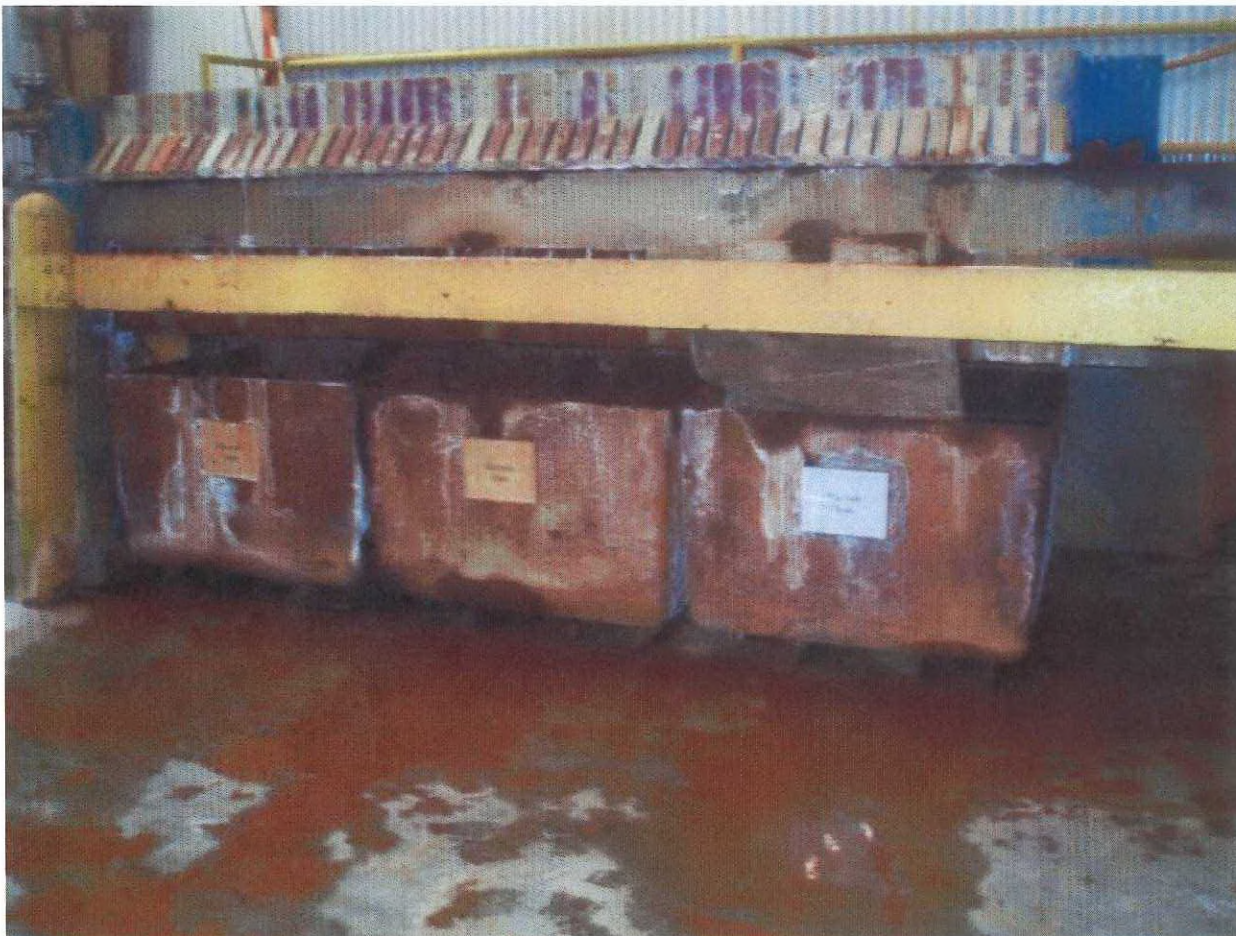
Photograph 51: Bins for collection of filter cake underneath a filter press in the Water Treatment Plant at Quemetco, Inc., Indianapolis, Indiana. The digital photograph was collected on May 20, 2009, at approximately 8:06 A.M (CST). The photographer was Todd Brown, U.S. EPA. The filename is P5200051.

At the Water Treatment Plant, I noted six bins for collection of filter cake located underneath two filter presses (photographs 51 and 52). The bins were labeled, "Recycle Iron." Questioning of Messrs. Wheat and Kelsey, and an employee working at the Water Treatment Plant, revealed that

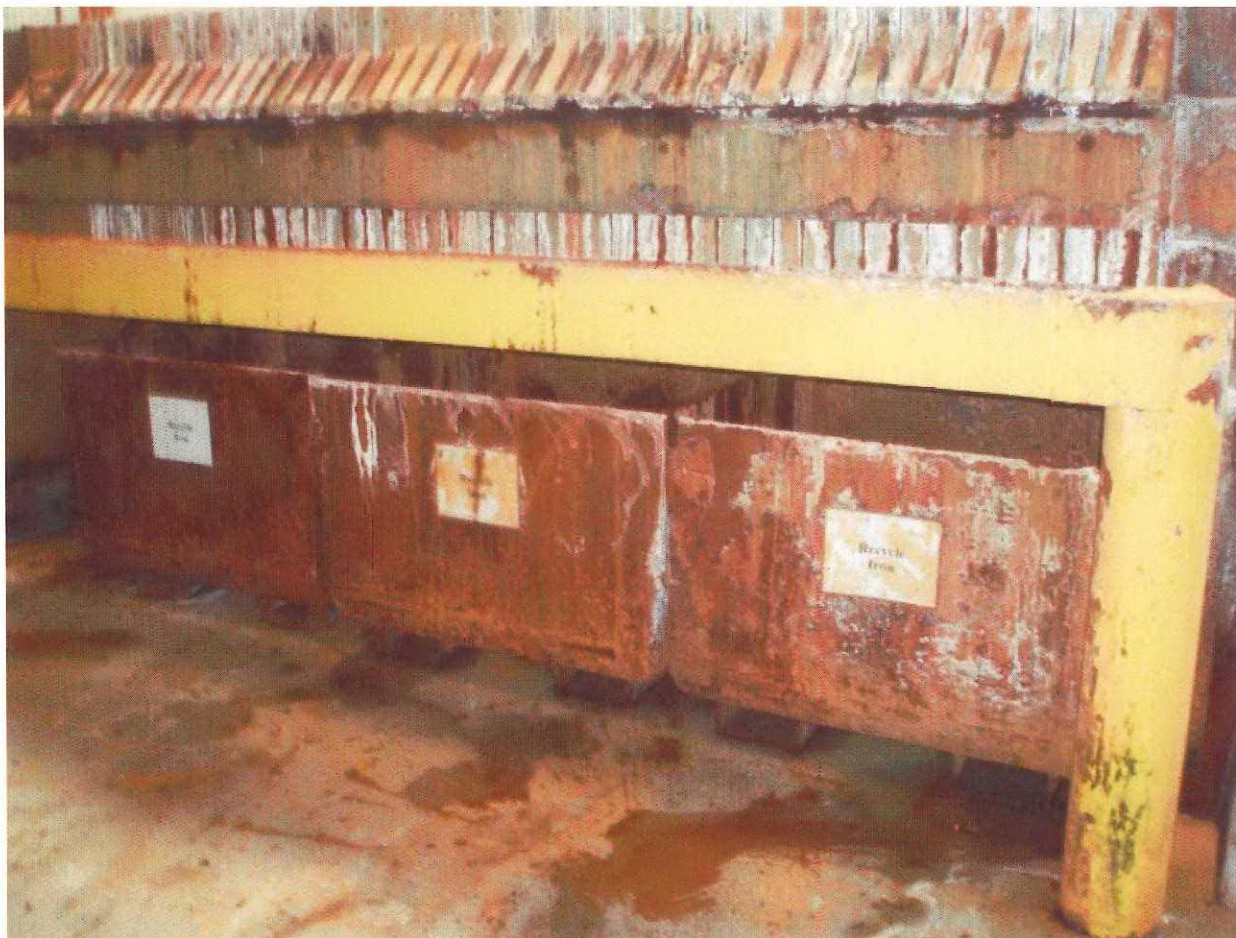
Photograph 52: Bins for collection of filter cake underneath a filter press in the Water Treatment Plant at Quemetco, Inc., Indianapolis, Indiana. The digital photograph was collected on May 20, 2009, at approximately 8:06 A.M (CST). The photographer was Todd Brown, U.S. EPA. The filename is P5200052.
